Fire resistance test report

Test standard: BS EN 1634-1:2014+A1:2018

Product: Hardware testing timber doors

Report number: 536715/R

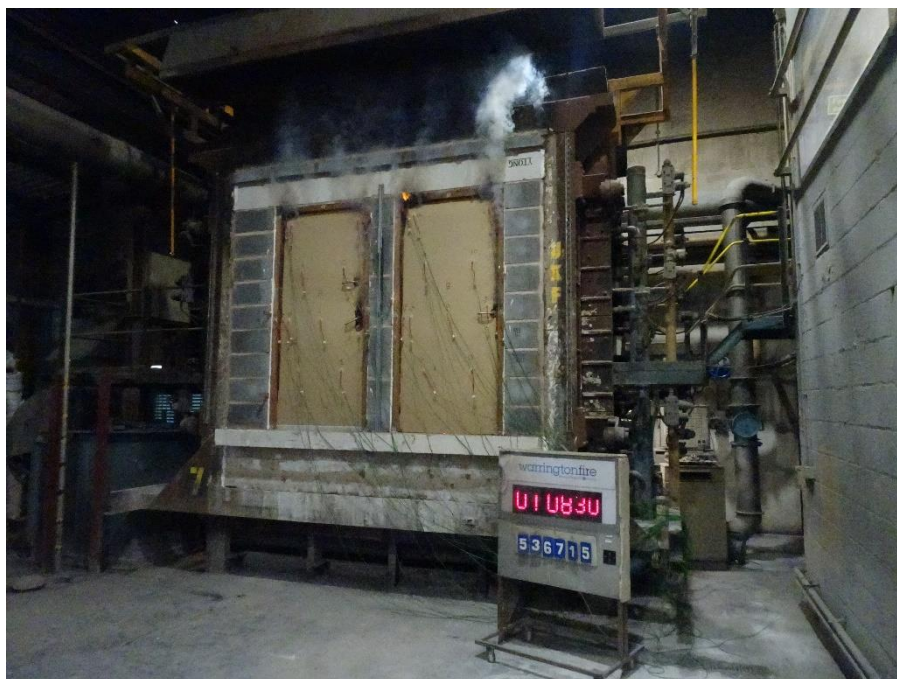
Figure 38 Unexposed face of the specimen at 68 minutes of testing

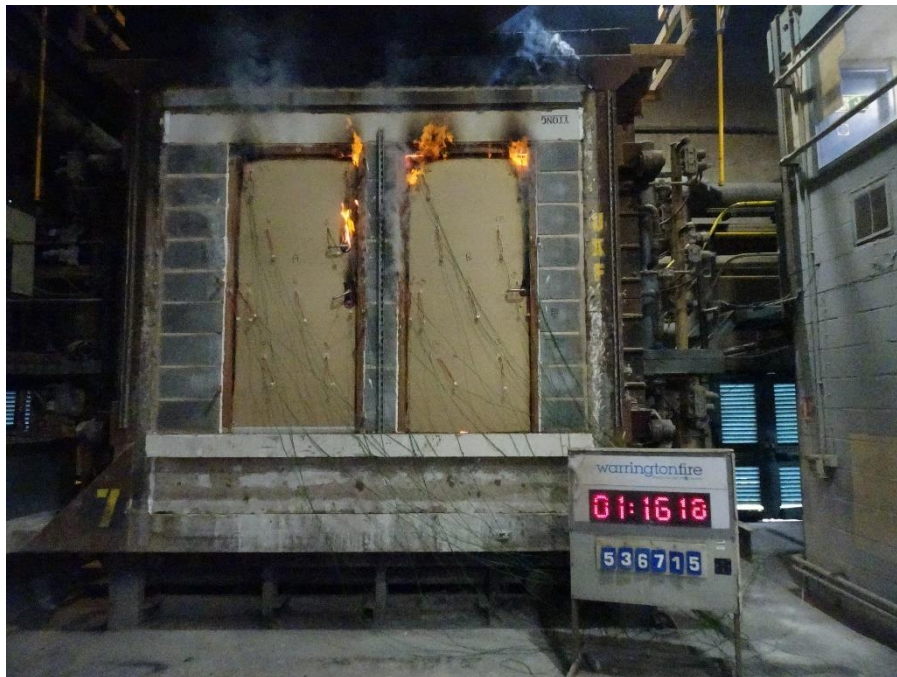
Figure 39 Unexposed face of the specimen at 76 minutes of testing

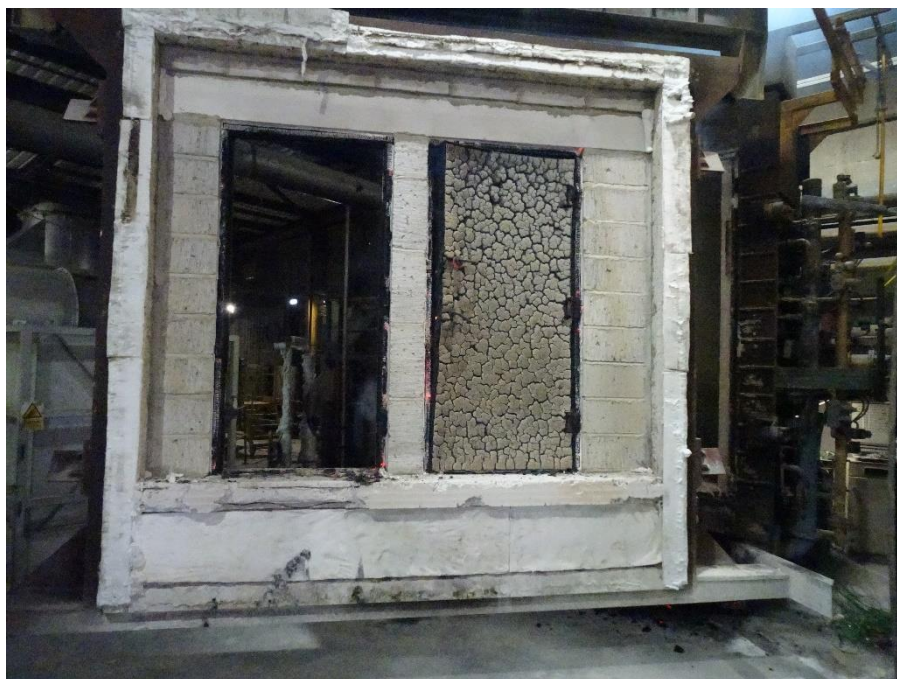
Figure 40 Exposed face of the specimen at the end of the test
